CONCRETE REPAIR BULLETIN

**Repairing
Post-Tensioned
Structures**

Evaluating Unbonded Post-Tensioned Slabs

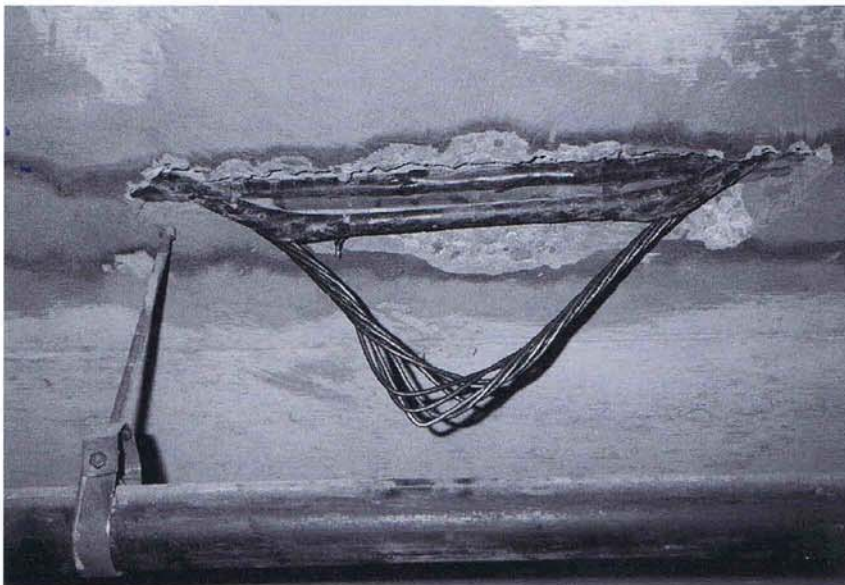
Strand eruption through a slab soffit.

of the strand. Strands erupting from a slab or projecting from a slab edge from sudden brittle fracture pose an additional threat to public safety. However, eruption is a relatively rare occurrence—most failures occur without external evidence. This point is significant since a high percentage of internal strand failures can go unnoticed. As extensive damage can exist without any external indicators, post-tensioned slabs exposed to a corrosive environment should be periodically reviewed by a qualified and experienced engineer.

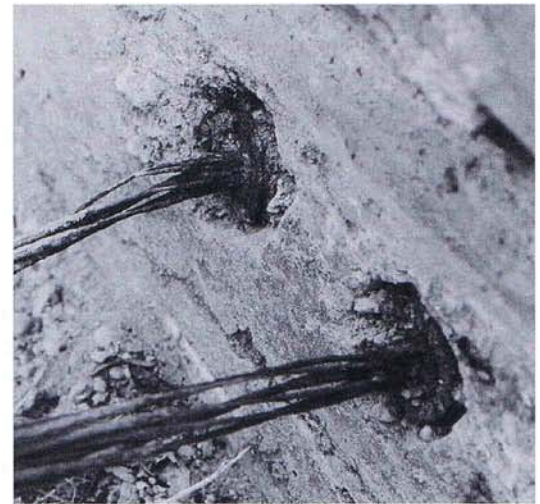
Top: Buried anchors exposed for inspection.

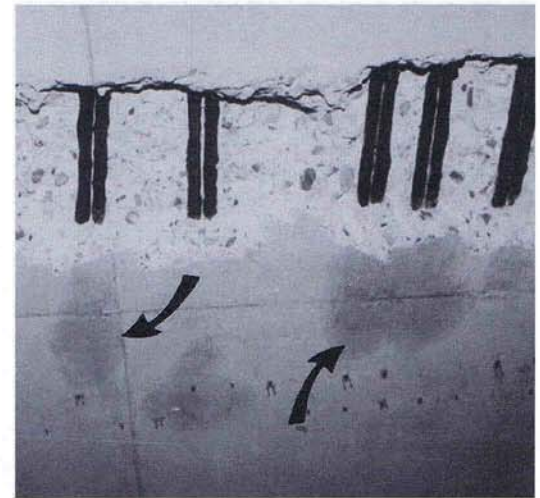
Grease stains on the slab soffit should be noted. These stains do not necessarily confirm strand damage, but they do indicate defects in the protective sheath. An opening in the sheath could allow water to enter the void created by the loss of grease.

Above: Grease stains on soffit indicating a damaged sheath.

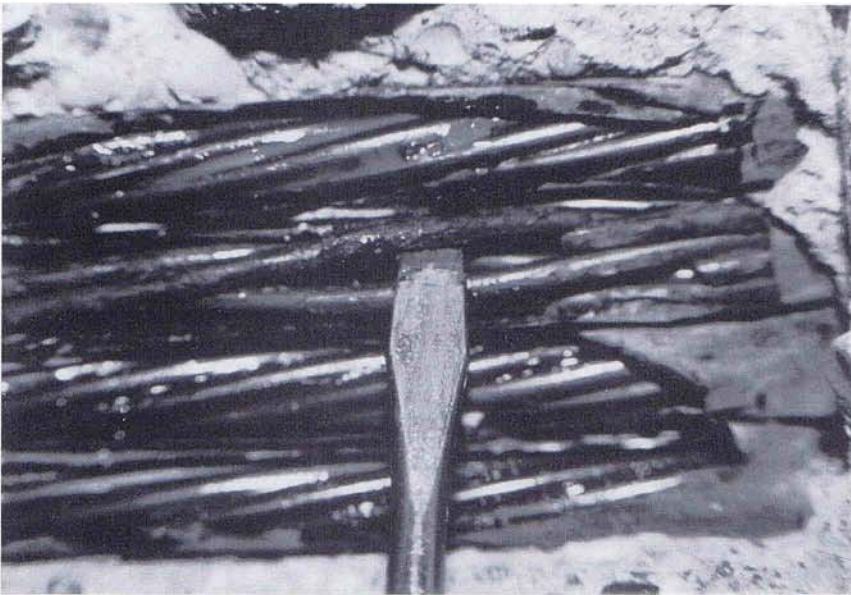
Trying to wedge apart the individual wires of the strand is one way to check for breakage.

There are several ways to check strands for breakage. The most reliable method is to attempt to wedge apart the individual wires of the strand. Another technique—deflecting the exposed strand with a prybar—has not been reliable. Strands which are readily deflected have been cut, and seemingly tight strands have been broken. Occasionally, the data provided by wedging the wires apart has proved to be misleading, but this is the exception, not the general rule.
